SUFFOLK MILLS GROUP

Newsletter

No. 54
JULY 1992

BEARING UP UNDER THE STRAIN IAN CLARK

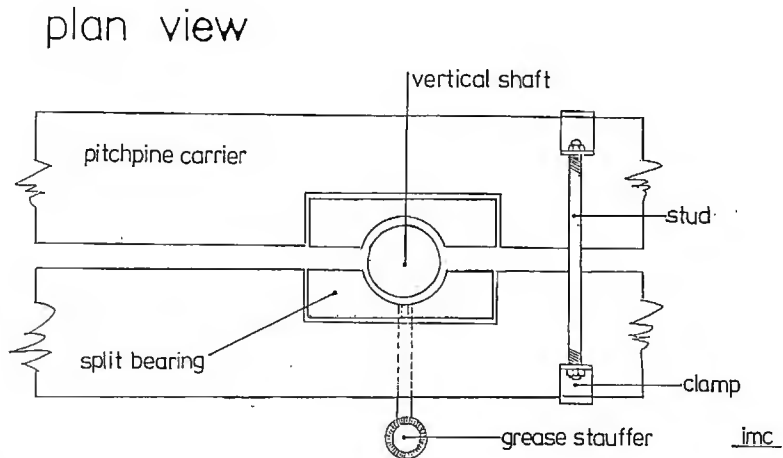
Fig.1 Vertical Shaft Neck Bearing

A particularly badly worn bearing was the secondary intermediate neck bearing situated on the vertical shaft. Its design and construction coupled with misalignment had resulted in severe

wear. Two pitchpine timbers halved and anchored at either end were rebated to carry a split brass bearing which when brought together in a scissor action supported the top end of the vertical shaft. Unfortunately the shaft was leaning out of true by $1\frac{1}{2}$ " thus wearing on one side of the bearing only. A major original design fault was the lack of any mechanical means of holding the split brass together, other than two pieces of softwood positioned between the pitchpine carriers and the floor joists. As a new brass bearing was needed it was decided to incorporate a mechanical clamp and introduce a lubrication system previously omitted. The design of clamp had to avoid defacing the original timbers and emulating a similar bearing just under the floor providing identical support (see Fig.1). This was also made from two timbers but of oak, bored the correct size through the timber with no inserted split brass bearing. Interestingly this bearing had always been lubricated via a stauffer with lubrication grooves cut into the bearing surface. The timbers were held together with long bolts passing right through and clamped in the normal method, with nut and washer. Unfortunately, when re-erected the fixings holding the bearing timbers to the floor joists above had been built in under a new floor covering and reinforcing mesh for plaster. The removal of this bearing for cleaning proved more difficult than expected. This reiterates the need to completely understand the relationship between building fabric and machinery. Due to the enclosed and inaccessible construction of this bearing and a real need for lubrication, a forced grease system was used via a screw-down cap lubricator or stauffer. The back of one of the bearing halves was drilled and tapped $\frac{1}{8}$ " BSP and a short length of pipe was passed through a hole drilled widthways in the pitchpine. This was coupled to a stauffer just above floor level, enabling the operator to lubricate with ease, knowing that an unseen bearing was receiving lubrication.

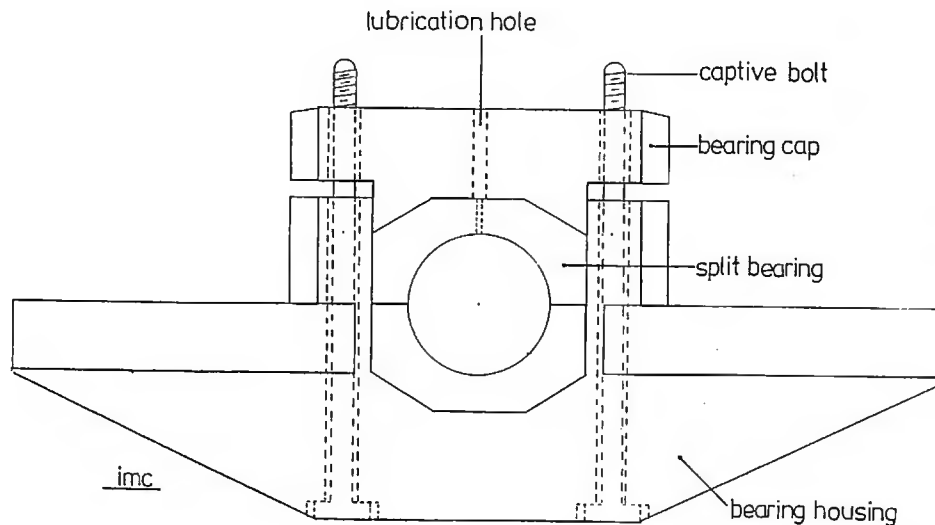
Fig.2 Vertical Shaft Top Neck Bearing

The top neck bearing was again badly worn, resulting in unacceptable movement, with the bearing support timber having to be given extra lateral support to counter-act the misalignment and wear. The support timber, held in position by two captive bolts from above, proved the theory that the machinery centre line had altered from original. The cast iron housing that held the neck bearing brasses, because of its design, had to be recessed into the timber before being positioned by four bolts. During the re-erection, to obtain the required alignment, the recessed slot had to be extended in a SW direction. Due to the poor condition of this timber - peppered with previous fixings - I made a replacement in chestnut. A new pair of split brasses was cast, machined and fitted, again incorporating oil grooves and grease stauffer. Also, because of its position and design, I fitted split pins in front of the bearing clamping nuts when finally installed to prevent any movement caused by vibration (see Fig.2 above).

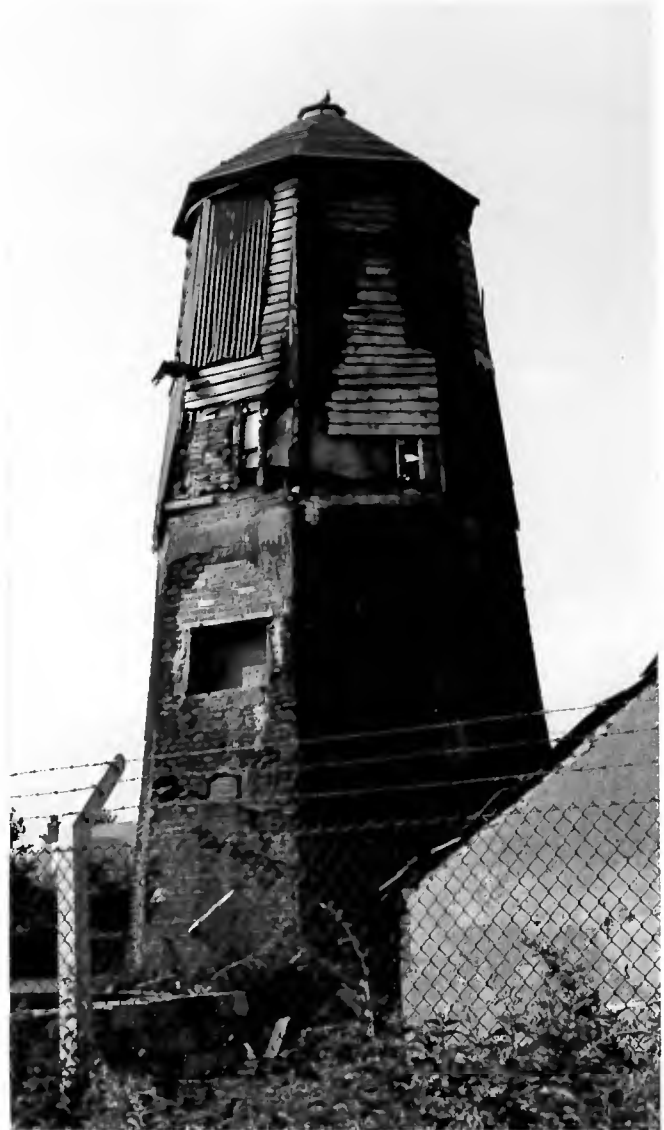
Walton smock mill in Felixstowe narrowly escaped destruction by fire on the evening of Thursday 18th June. It was only saved by the prompt and courageous action of Mr. Bloomfield, the owner. He saw smoke coming from the mill and after calling the fire brigade, fought the fire with buckets of water, climbing up into the smoke-filled tower. The brigade soon had the fire extinguished and the mill damped down. How it started is a mystery as there is no electricity in the mill and no inflammable substances or machines are kept there.

Walton mill after the fire, showing badly charred cant post & boarding

out repairs we could offer a small grant towards purchase of covering material.
