SUFFOLK MILLS GROUP

Newsletter

No. 54
JULY 1992

BEARING UP UNDER THE STRAIN IAN CLARK

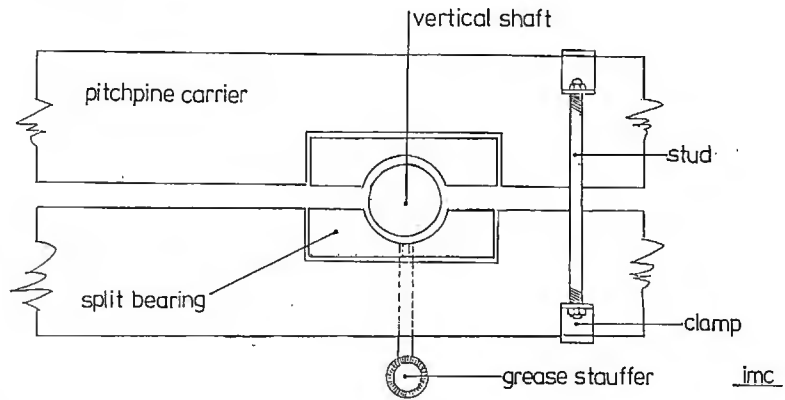
Fig.1 Vertical Shaft Neck Bearing

A particularly badly worn bearing was the secondary intermediate neck bearing situated on the vertical shaft. Its design and construction coupled with misalignment had resulted in severe

wear. Two pitchpine timbers halved and anchored at either end were rebated to carry a split brass bearing which when brought together in a scissor action supported the top end of the vertical shaft. Unfortunately the shaft was leaning out of true by $1\frac{1}{2}$ " thus wearing on one side of the bearing only. A major original design fault was the lack of any mechanical means of holding the split brass together, other than two pieces of softwood positioned between the pitchpine carriers and the floor joists. As a new brass bearing was needed it was decided to incorporate a mechanical clamp and introduce a lubrication system previously omitted. The design of clamp had to avoid defacing the original timbers and emulating a similar bearing just under the floor providing identical support (see Fig.1). This was also made from two timbers but of oak, bored the correct size through the timber with no inserted split brass bearing. Interestingly this bearing had always been lubricated via a stauffer with lubrication grooves cut into the bearing surface. The timbers were held together with long bolts passing right through and clamped in the normal method, with nut and washer. Unfortunately, when re-erected the fixings holding the bearing timbers to the floor joists above had been built in under a new floor covering and reinforcing mesh for plaster. The removal of this bearing for cleaning proved more difficult than expected. This reiterates the need to completely understand the relationship between building fabric and machinery. Due to the enclosed and inaccessible construction of this bearing and a real need for lubrication, a forced grease system was used via a screw-down cap lubricator or stauffer. The back of one of the bearing halves was drilled and tapped $\frac{1}{8}$ " BSP and a short length of pipe was passed through a hole drilled widthways in the pitchpine. This was coupled to a stauffer just above floor level, enabling the operator to lubricate with ease, knowing that an unseen bearing was receiving lubrication.

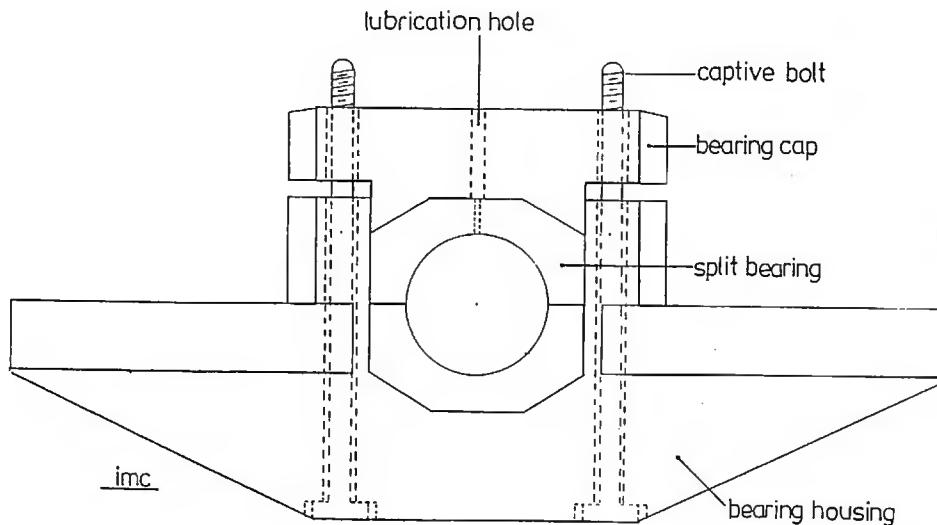
Fig.2 Vertical Shaft Top Neck Bearing

The top neck bearing was again badly worn, resulting in unacceptable movement, with the bearing support timber having to be given extra lateral support to counter-act the misalignment and wear. The support timber, held in position by two captive bolts from above, proved the theory that the machinery centre line had altered from original. The cast iron housing that held the neck bearing brasses, because of its design, had to be recessed into the timber before being positioned by four bolts. During the re-erection, to obtain the required alignment, the recessed slot had to be extended in a SW direction. Due to the poor condition of this timber - peppered with previous fixings - I made a replacement in chestnut. A new pair of split brasses was cast, machined and fitted, again incorporating oil grooves and grease stauffer. Also, because of its position and design, I fitted split pins in front of the bearing clamping nuts when finally installed to prevent any movement caused by vibration (see Fig.2 above).

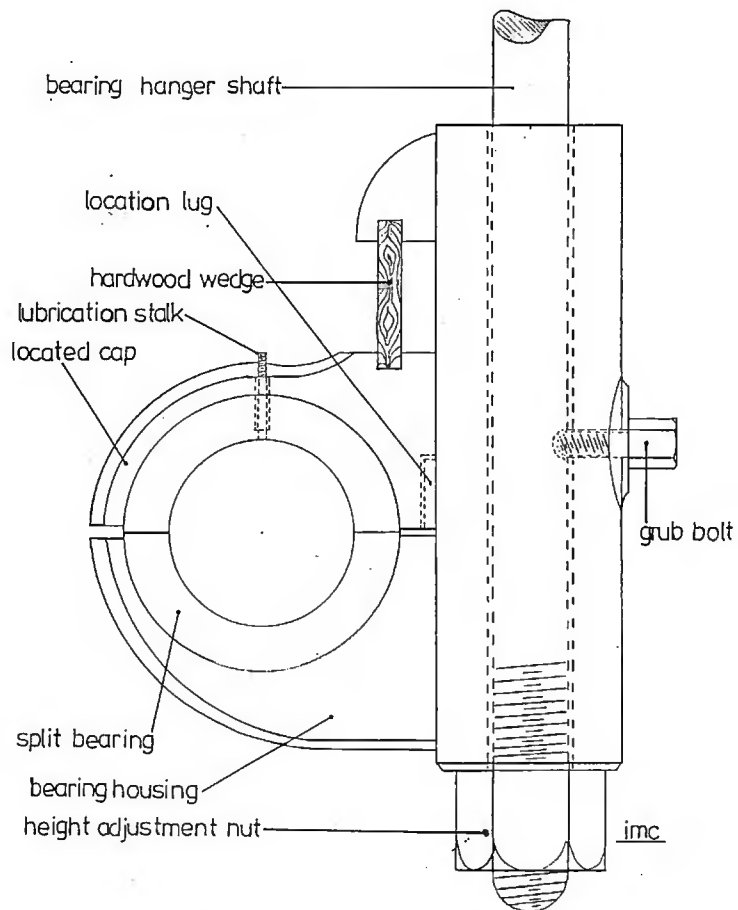
Fig.3 Auxiliary Drive Shaft Bearing

With the crown wheel finished I began work on the auxiliary and drive shafting and bearings (see Fig.3). The shafting is divided into two parts, supported on four hanging bearings fixed to adjustable timbers and coupled together when required by a dog clutch. In recent years only the first half of shafting was used, to operate the sack hoist. The second part was purely placed in situ as both sets of split bearings and housing caps were missing. The dog clutch situated on this half slides on a back tapered spline, i.e. away from the working position. As it is disengaged, the taper of the

On examining the first half of shafting, I was shocked at the condition of the split brasses. One bottom half had worn clean through with the wrought iron shaft running in the cast iron housing. This had resulted in some of the worst journal damage I have ever seen. The next journal along had suffered similar damage but this had been caused more by misalignment and minimal lubrication. To be able to run this half of shafting a complete rebuild was required. Because of the cost of pattern making it was decided to rebuild both halves of shafting, enabling the outer half to drive auxiliary machines in the future. Whilst machining the first half, the badly scored journal needed reducing by $\frac{3}{16}$ " to produce a new bearing surface. Luckily there was sufficient 'meat' to allow this. The second journal was also machined but needed far less work. When offering the shaft into the lathe, the position of the final drive gear interfered with a comfortable set-up. Unfortunately the key securing this gear had been welded into position making any removal very difficult, so it was left. Fortunately the two journals on the outer half, because of non-running, were in good condition. New housing caps and brasses were cast and machined using grey iron and LB2 bronze.

The brasses are held within the housings by a cast cap with a parallel slot across it. A hardwood tapered wedge is used to bring the bearing halves together. The design of the hanging bracket, with adjustable housing and cap, is not a very sophisticated design but has been rebuilt as original.

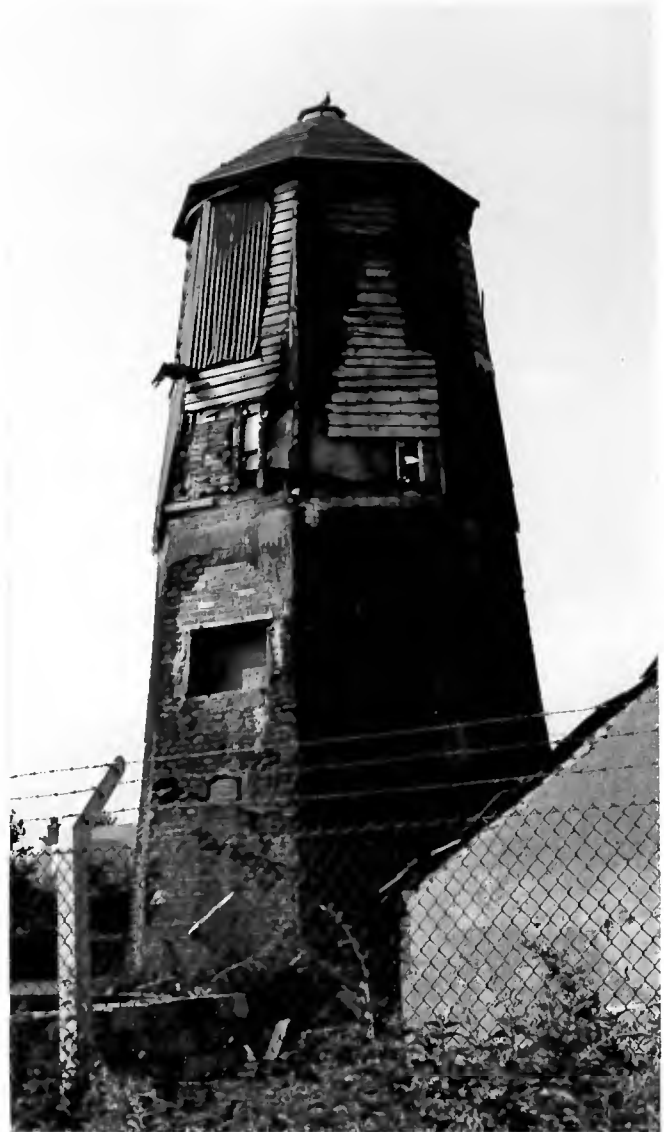
Walton smock mill in Felixstowe narrowly escaped destruction by fire on the evening of Thursday 18th June. It was only saved by the prompt and courageous action of Mr. Bloomfield, the owner. He saw smoke coming from the mill and after calling the fire brigade, fought the fire with buckets of water, climbing up into the smoke-filled tower. The brigade soon had the fire extinguished and the mill damped down. How it started is a mystery as there is no electricity in the mill and no inflammable substances or machines are kept there.

No machinery survives in the mill but it is a nice little smock tower and the rarity of smock mills in Suffolk is recognised by its listing. A good roof was fitted about 10 years ago but now the corrugated steel sheets which covered the old boarding and kept the weather out for so long have mostly blown off and the eight sides have gaping holes in them. We plan to meet Mr. Bloomfield and hopefully if he is willing to carry

Walton mill after the fire, showing badly charred cant post & boarding

out repairs we could offer a small grant towards purchase of covering material.
