SUFFOLK MILLS GROUP

Newsletter Number 12

SEPTEMBER 1979

'WORK-IN' AT BARDWELL AND STANTON

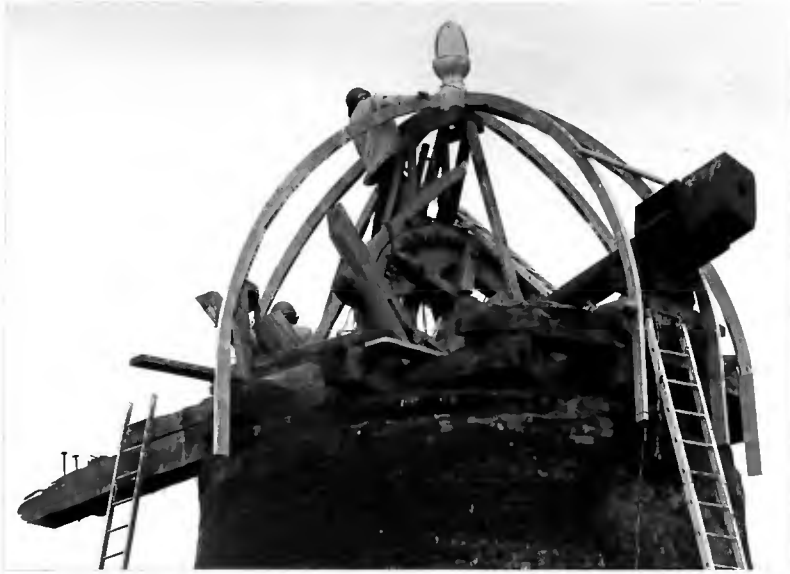
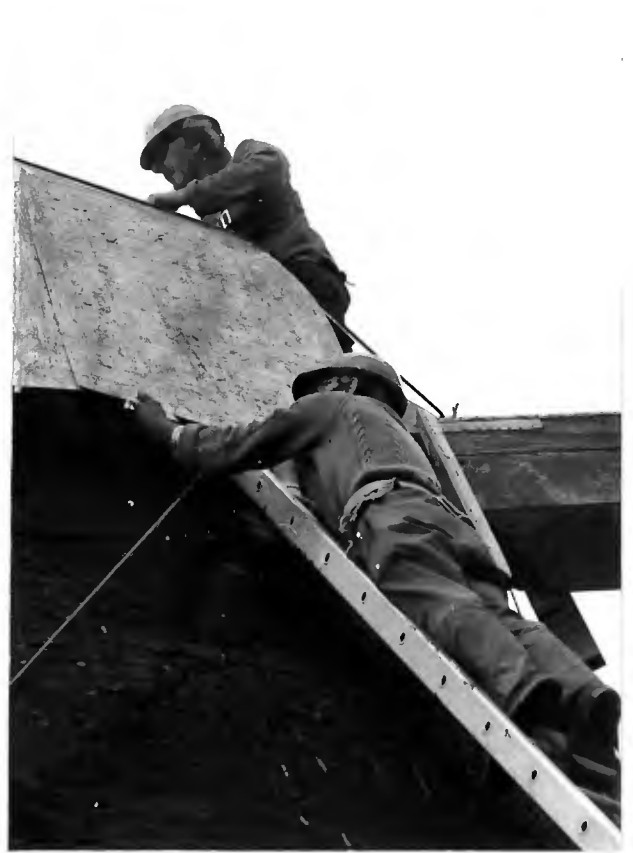
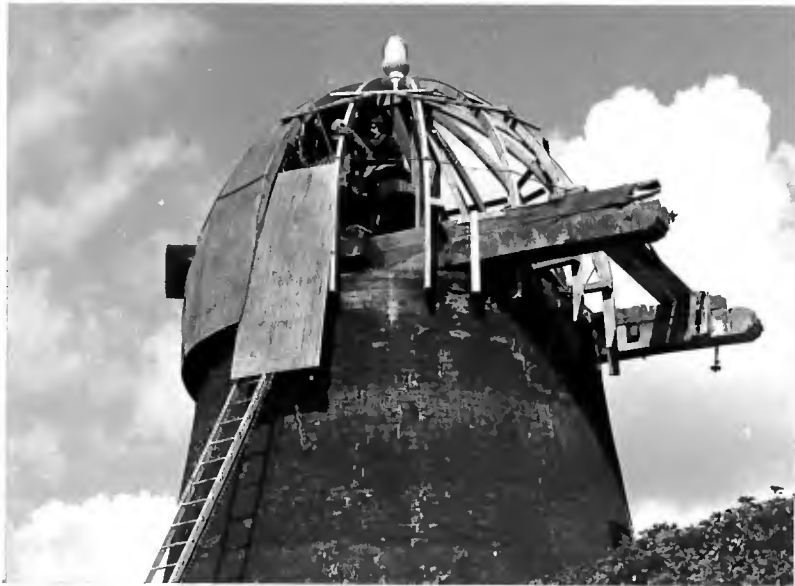
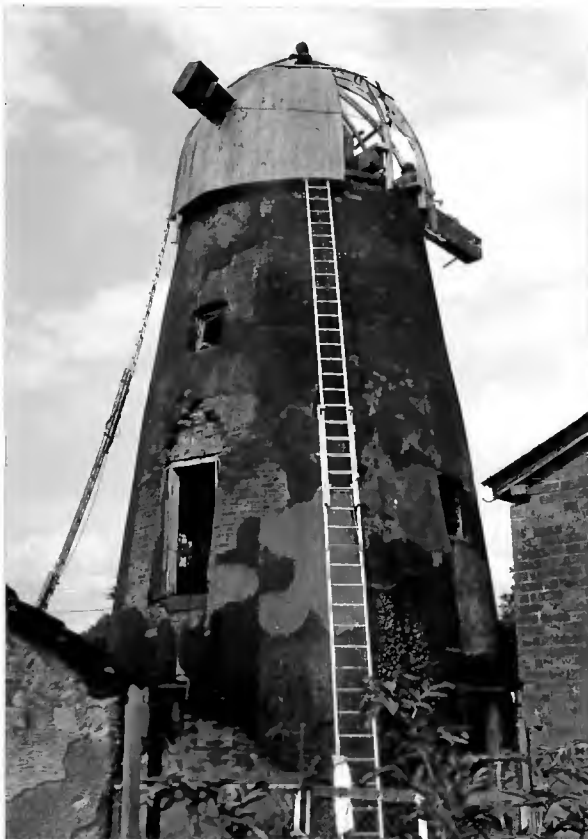
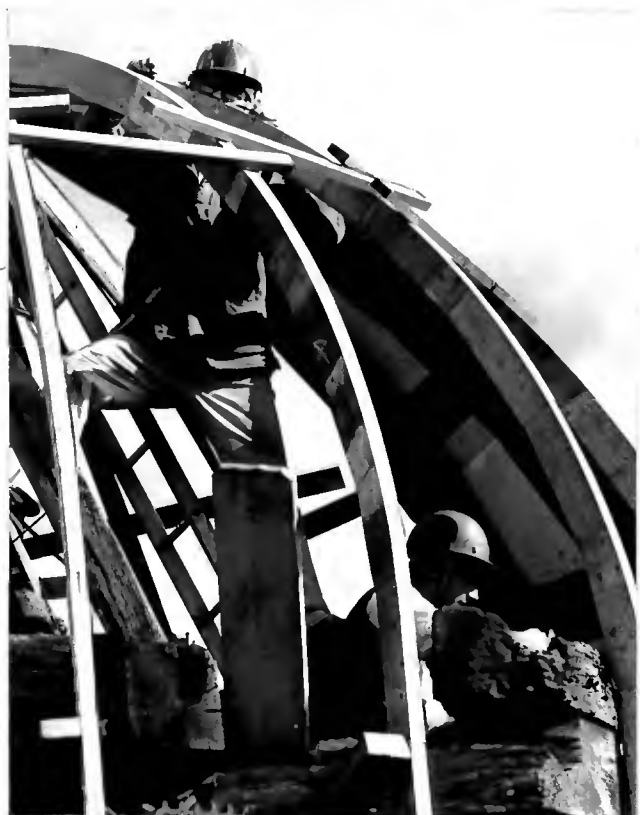
BARDWELL WORK-IN

Top Left: the first ribs going in

Left: a sheet being hauled up

Above: Don Porter & Chris Hullcoop fixing one of the lower sheets

Below: Don Porter measuring up for the next sheet (Photo.: Mr. Robbins)

Below, Left: the mill on the morning of Wednesday August 15th.

them to the cap. All the ribs were identical and had been pre-marked at six inch intervals. It was then easy to measure across at these points and then measure and cut out the sheets on the ground with a large hand guillotine. We fitted most of the large lower sheets first, leaving the smaller upper sheets until last in case another gale blew up. As we worked around the cap we flashed over the joints with bitumen-backed flashband. We sometimes had to leave a joint without flashing because of light rain or dampness (when the flashing won't stick) and these we had to finish by lowering ourselves mountaineer style from the finial. By now the roof at Stanton was finished and there had been sufficient time to give three coats of paint before removing the scaffold platform. There is no doubt that scaffolding can be a great help in much though not all repair work to mills. The only way we could have used it at Bardwell would have been from the ground and we just did not have sufficient poles, boards and clips to do this.

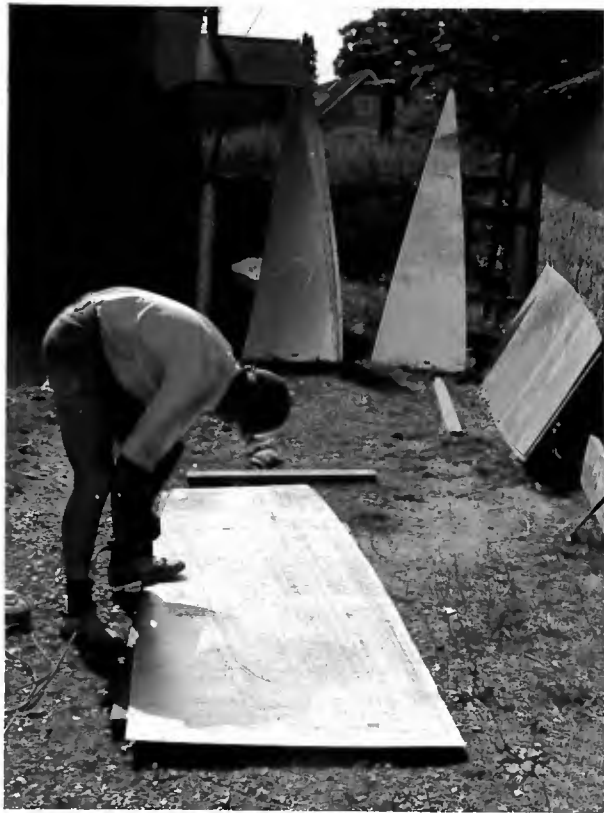
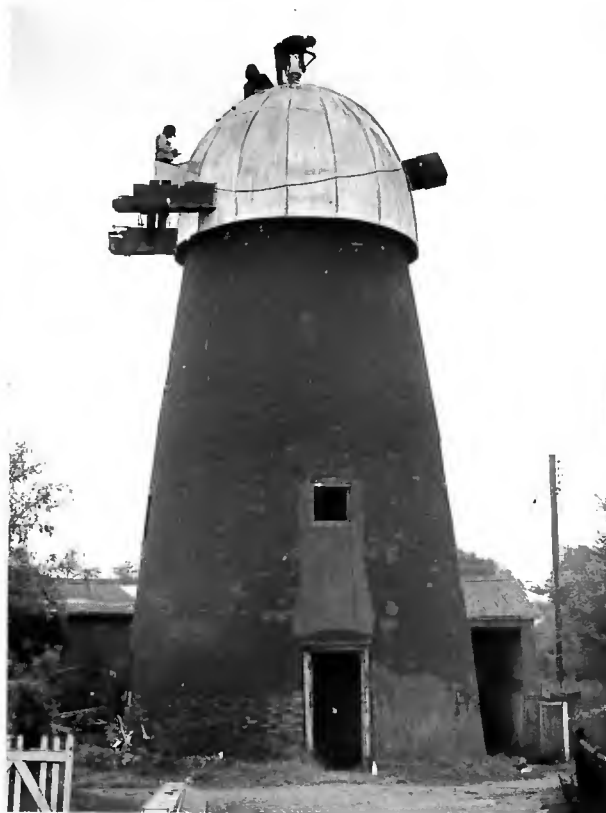
BARDWELL

Above: Chris Baker drilling the metal sheets by the mill

Above, Right: the mill being 'topped out' on the final day

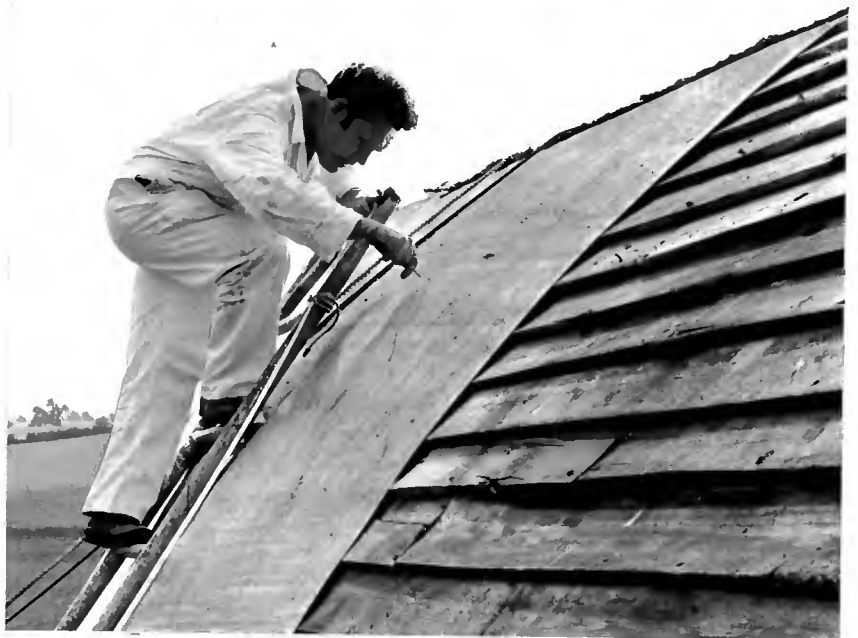
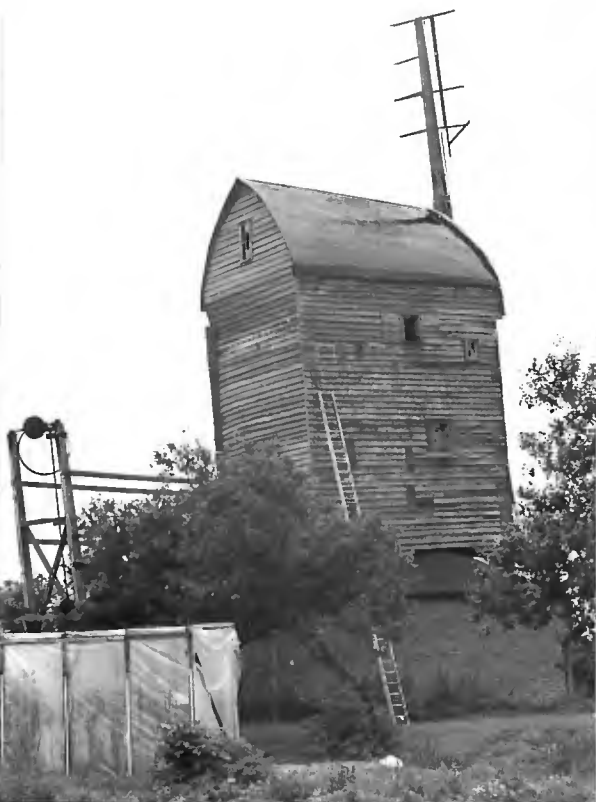
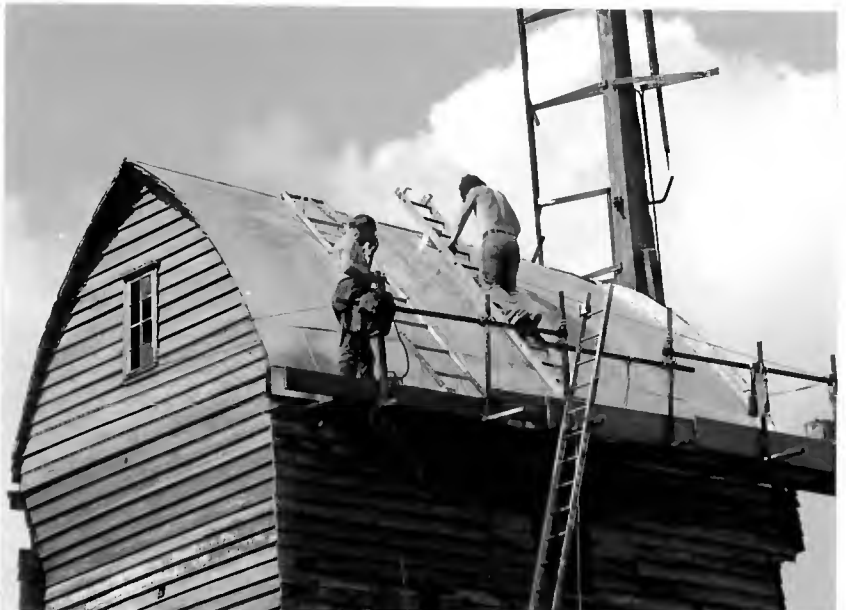
STANTON

Right: Alan Wallis at work on the roof (Photo.: Mr. Robbins)

Below, Right: painting the roof

Below: the work completed

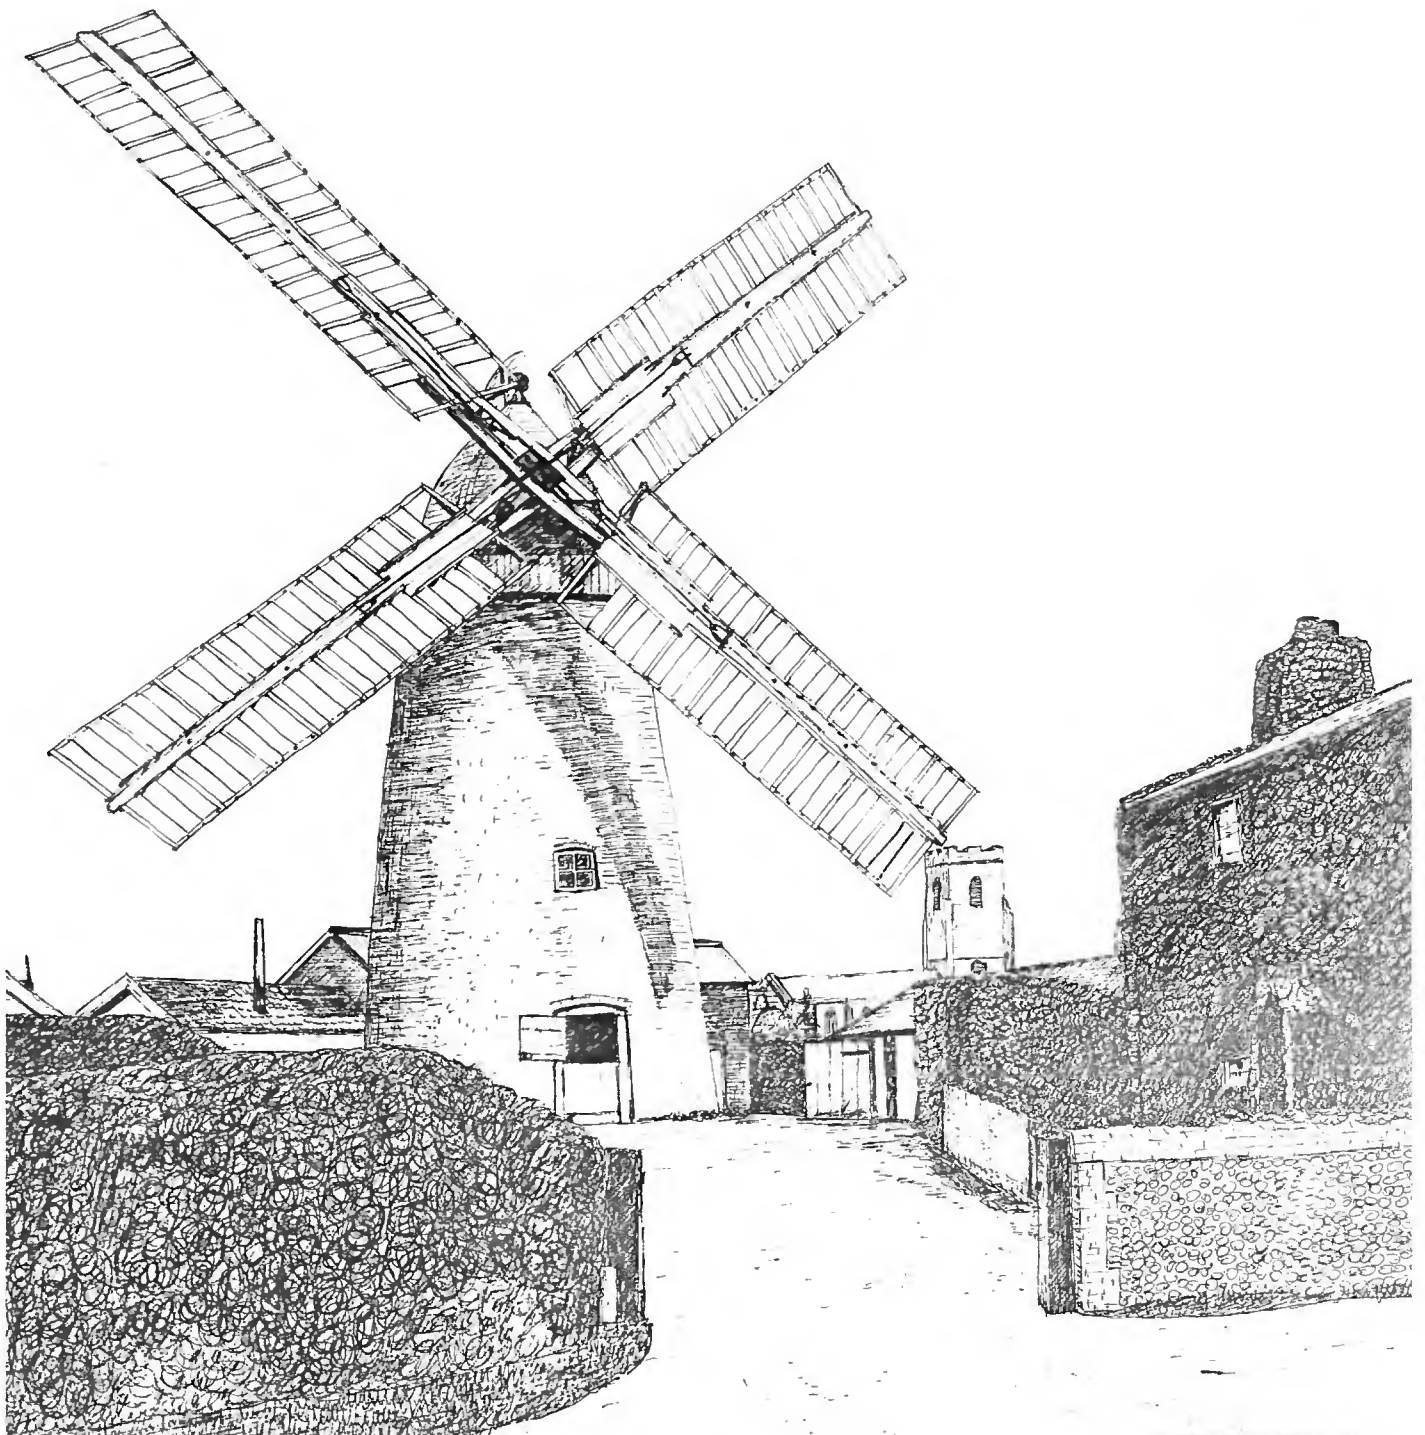
The tower is of red brick, with a slight convex batter, and stands 32' 9" high to the curb. Internal diameters at the base and curb are 17' 6" and 11' 6" respectively and the walls are two bricks (19") thick. The curb is timber with an iron rack with upward facing teeth (similar to that at Pakenham mill).

The cap was a typical 'beehive' of 14' 6" diameter and was 11' 3" high above the curb. The 12" square sheers had been spliced and overlaid. The weatherbeam is curved and is 21" by 10" at the centre. The cap runs on 11 rollers, with seven centering wheels. The iron two piece windshaft ran on a wooden neck bearing and is 11" diameter at the neck.

The clasp arm brakewheel is of 8' diameter, with 85 cogs; a few of these could be removed to allow engine drive to be used to run the upright shaft. The brake is of wood and was operated by the usual brake lever with catch. The wallower is iron, 35"

diameter, with 35 cogs. It is mounted on a wooden upright shaft, 12" square with chamfered corners. The main bridgetree curves under the great spur wheel, which is clasp arm, of 6' diameter. The original wooden cogs have been partly sawn off and an iron ring bolted on to increase the diameter. There are 102 cogs. An iron bevel ring under the wheel serves no useful purpose; possibly it is a remnant of an earlier auxiliary drive.

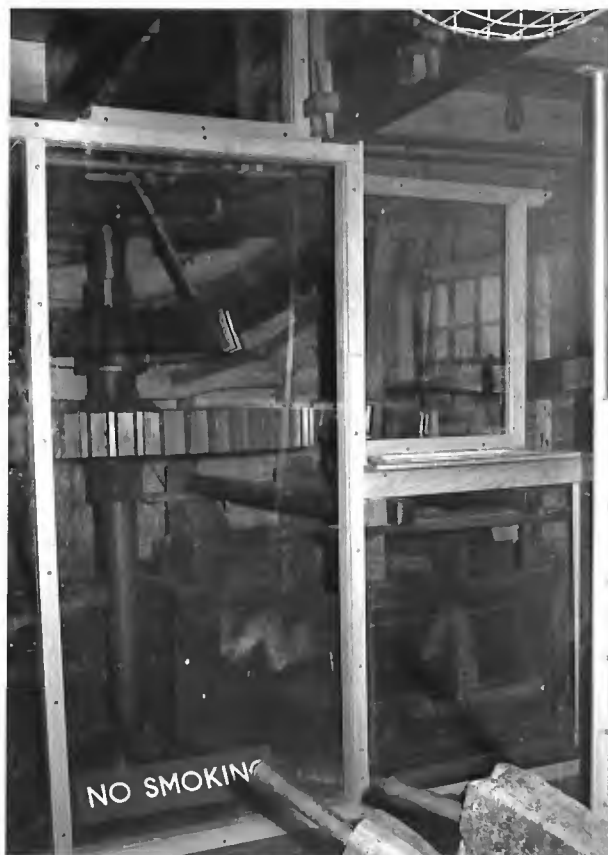
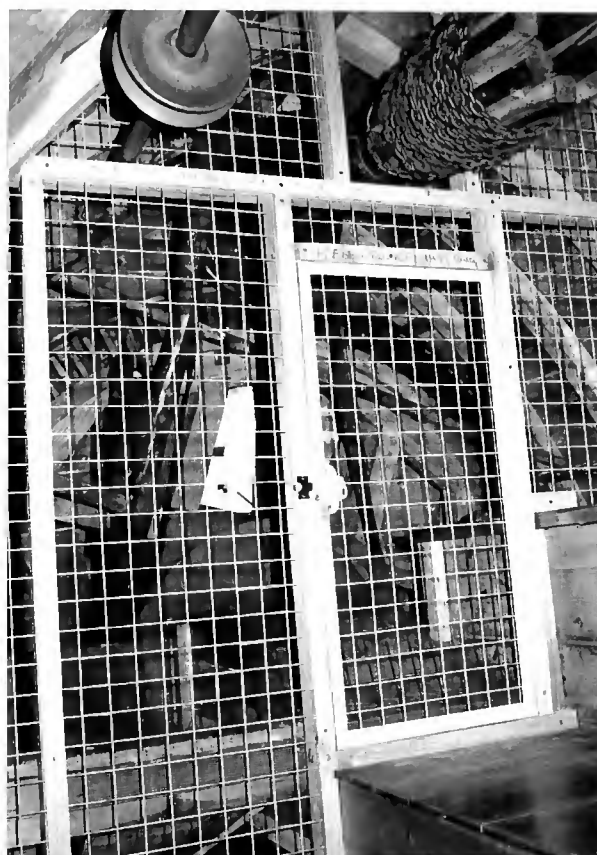
'SAFETY FIRST' AS SAXTEAD RE-OPENS

Saxtead Green mill re-opened to the public just before August Bank Holiday, exactly four months after the fatal accident in the mill (see Newsletter 10). The Department of the Environment have completely reviewed the question of safety at the mill, and there is now complete protection from all the moving machinery in the buck. The two pairs of stones and their drive in the head of the mill are now 'exhibited' behind perspex screens which stretch from floor to ceiling (see photograph below, left), while on the bin floor above the brakewheel is screened by a coarse wire grill, with a door for access through to the storm hatch (below, right). The lower portion of the windshaft on the stone floor is similarly protected. Other measures include guards

at the top of steps, the covering of all other voids with perspex, new steps in the buck and roundhouse with anti-slip surface and guards on the fan carriage wheels (the last two measures have apparently been in for some time).

For the purist, of course, this work has destroyed what little atmosphere there was inside this largely rebuilt mill, but considering the very large numbers of visitors the mill attracts, and the cramped conditions, perhaps it's only surprising the gear was left unguarded for so long. If a mill has to be made 'safe' in this manner, then Saxtead is the obvious choice, but it would be terrible if all mills capable of turning were given similar treatment. Also, one wonders how long it will be before the perspex is defaced by graffiti artists - perhaps it would have been better to have used a wire grill screen on the stone floor as well. M.B.

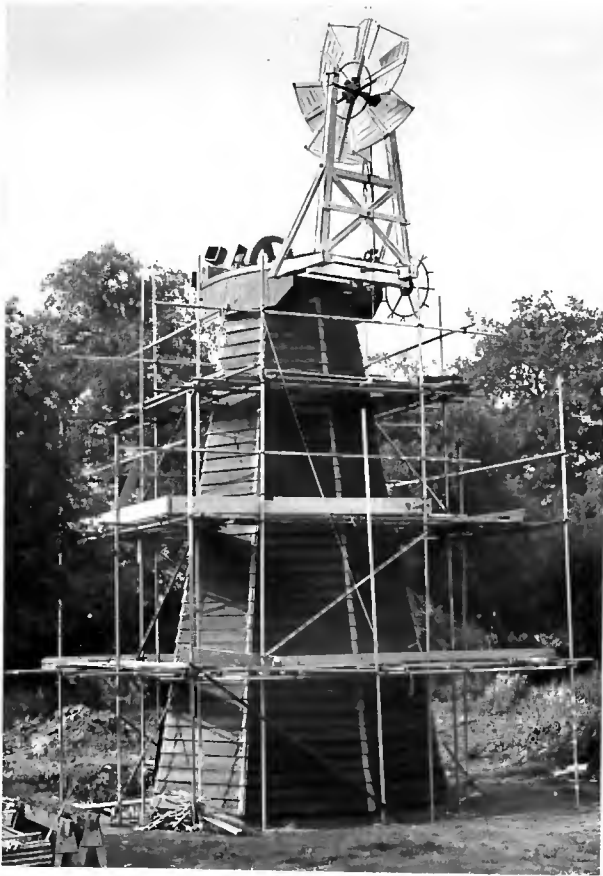
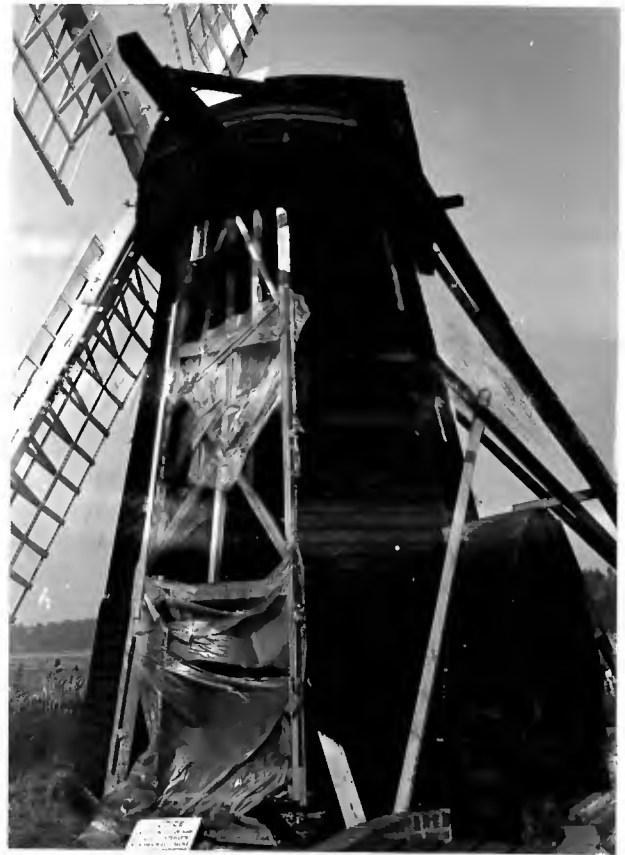
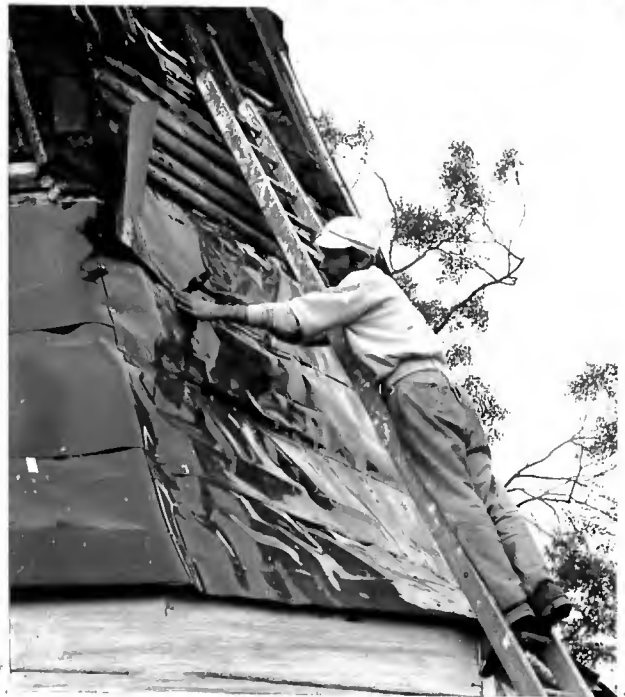
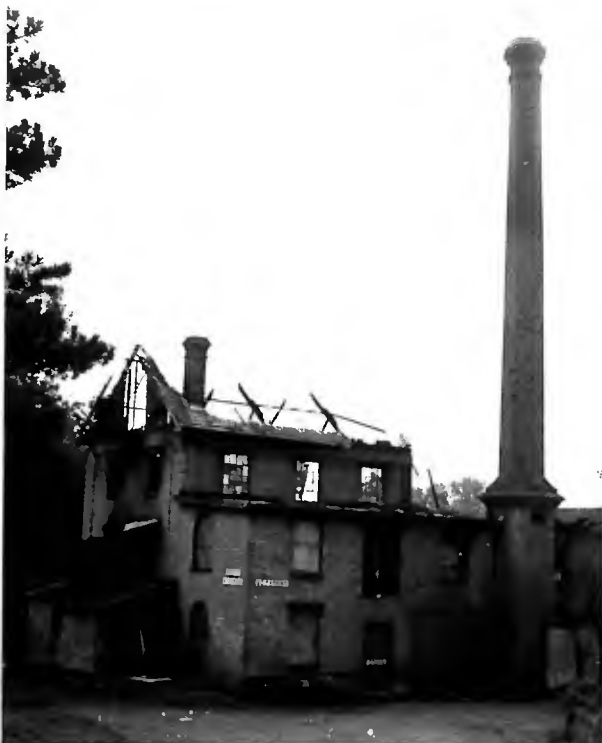
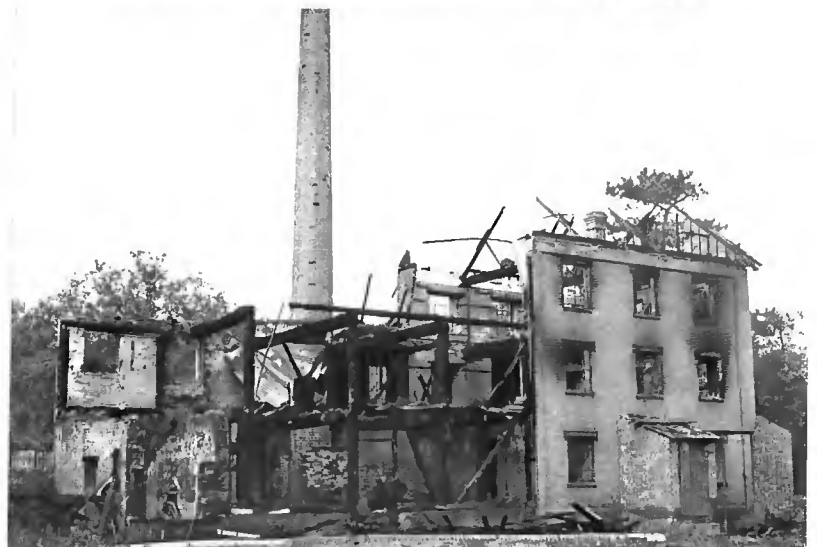
MILLS IN THE NEWS

Above: East Bridge mill (September 1st.)

Above, Right: Herringfleet under repair on September 12th.

Right: Chris Hullcoop at work on weather-proofing Drinkstone smock mill (see 'Events')

Below: Clare watermill after the fire. The shell of the steam mill still stands but the watermill building has been destroyed.

These are still in progress and we therefore had to cancel our open day planned for August 26th.. So far one new cant post has been fitted and another spliced, and four sides of the tower have been re-framed as necessary (see photograph opposite). The brakewheel has also been re-wedged and some new cogs fitted in the wallower. Jameson Marshall Ltd. have now obtained the timber needed to complete the repairs and are pressing ahead to finish the job before the winter (and who can blame them). We hope to run the mill round about New Year, but more details of this in our next Newsletter.
