SUFFOLK MILLS GROUP

Newsletter Number 21

OCTOBER 1981

THELNETHAM WORK-IN PETER DOLMAN and MARK BARNARD

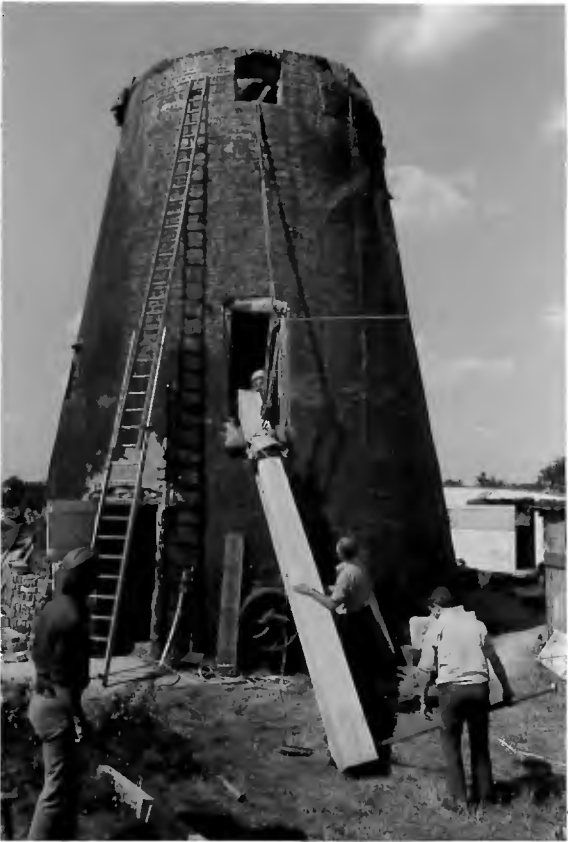
Above: the new stone floor beam being hoisted into the mill

haul the new stone floor beam into position via the loading door. This oak beam weighed about three times more than the rotten one it replaced and must have been close to half a ton, but the operation went smoothly and it was soon safely in place.

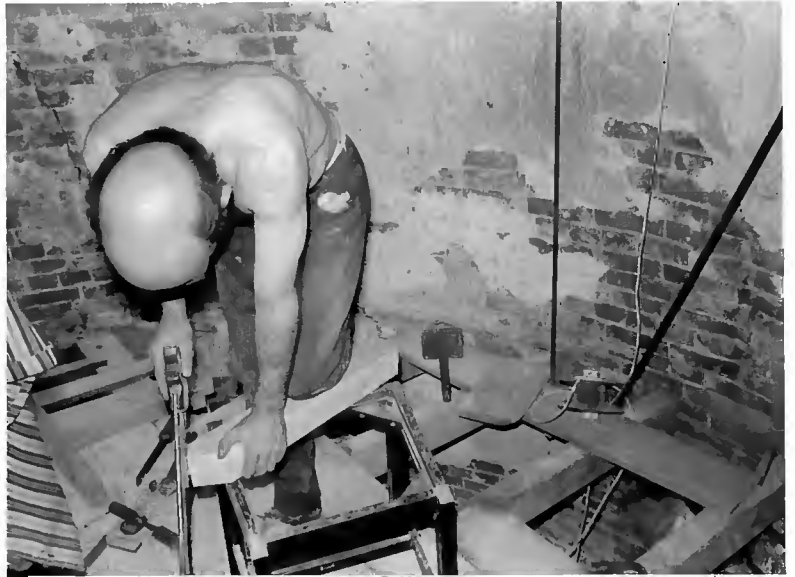
Above Right: floorboarding in progress on the dust floor

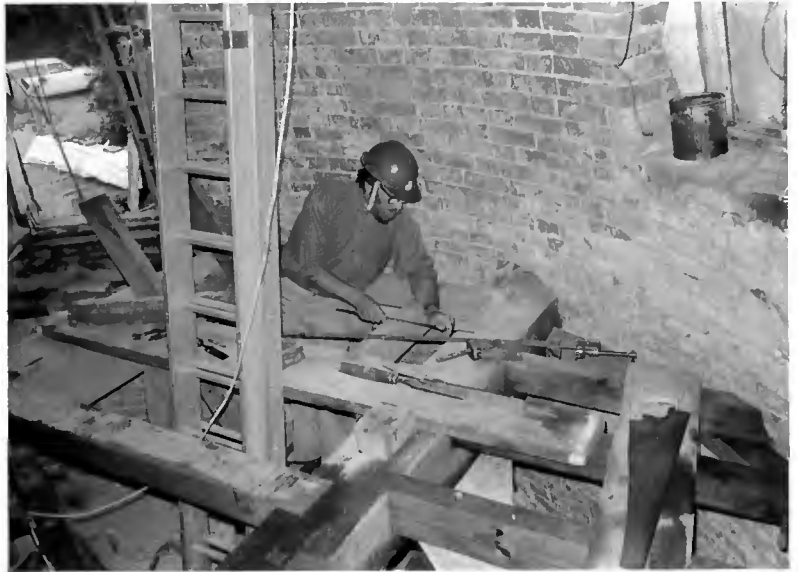
Right: joisting the stone floor

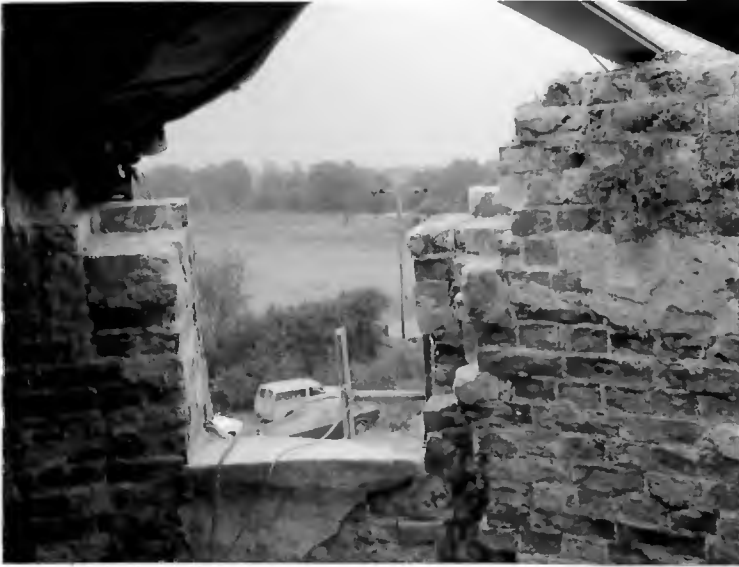
Above Left: the dust floor window opening before rebuilding

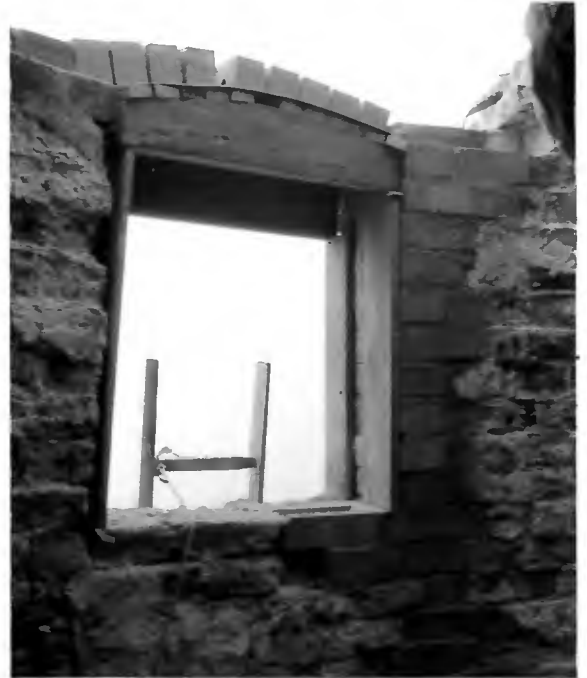
Above: dust floor window showing surrounding brickwork rebuilt

The main task at the top of the tower in the second week was the rebuilding of the brickwork. In preparation, polythene was laid on the new dust floor boarding to save it from damage, and the remainder of the old curb was removed. The tower is being taken down four courses and rebuilt to a perfect circle, using the best of the old bricks topped off with two courses of engineering brick to provide a firm base for the new curb. A weak point, which had already allowed the tower to distort, was the top window. To strengthen this after the new arch had been built, the backing brickwork was replaced by a reinforced concrete lintol which should manage better than the old timber one did. In order to get the new brickwork perfectly level and circular a trammel was built on the upright shaft, which was itself made vertical and able to turn by means of a special bearing on the dust floor. To ensure that the upright shaft was absolutely vertical and that the trammel described a perfect, level circle we used a water level, a long water-filled rubber tube with sight glasses at either end. As the water meniscus in each sight glass is always at exactly the same level, by trial and error we were able to level up the trammel to within $\frac{1}{32}$ inch. Rebuilding the brickwork was a very slow job because of the need to work to fine tolerances, each brick having to be checked individually. Even so, we managed to complete over half of the job - the sunny weather was a great help - leaving the remainder to be tackled next summer. A start was also made on cutting out the old holding-down bolts which had weakened the walls over the years. The brickwork will be made good and six new holding-down bolts will be installed in undamaged areas of wall.

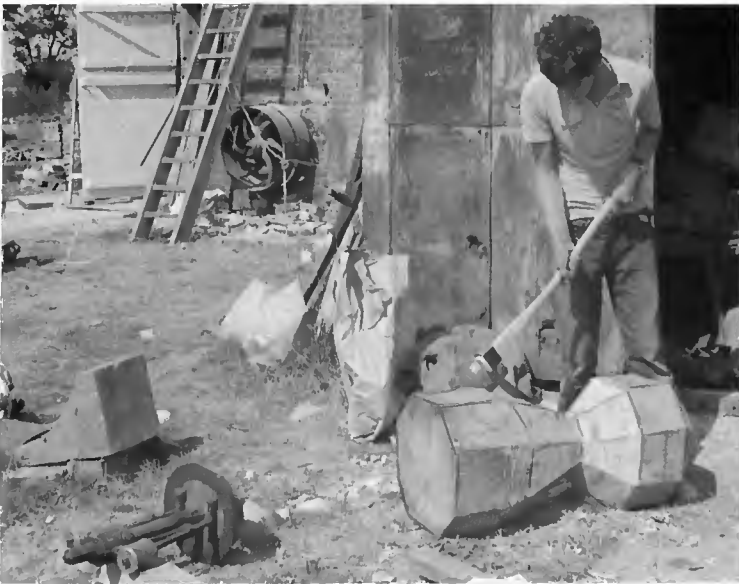
Left: Richard Budgie rough-shaping the oak finial with an adze
